Former Plainwell Impoundment 2009 Bank Conditions Monitoring Report
Allied Paper, Inc./Portage Creek/Kalamazoo River Superfund Site

Date:
October 28, 2009

**Allied Paper, Inc./Portage Creek/
Kalamazoo River Superfund Site**

**Former Plainwell Impoundment
2009 Bank Conditions Monitoring
Report**

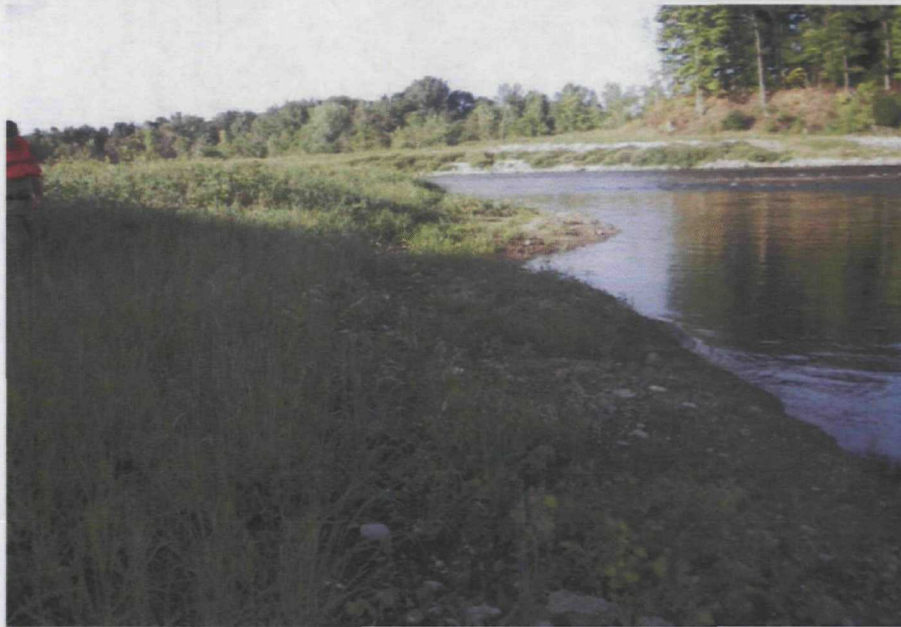
1

Photo #1: BEHI Area B (Low Erosion Potential) on north bank upstream of the former Plainwell Dam, looking southeast.

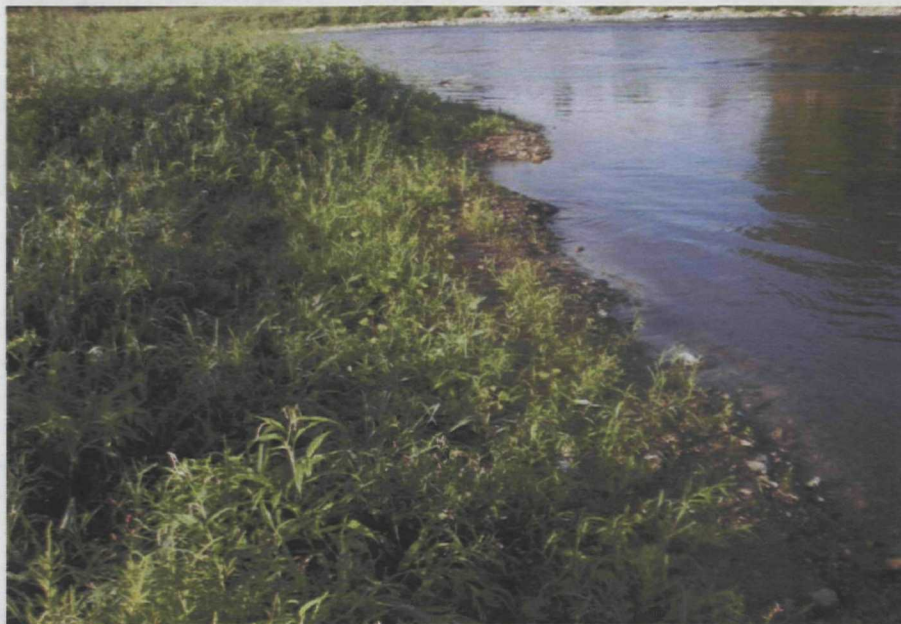
2

Photo #2: BEHI Area C (Low Erosion Potential) on north bank upstream of the former Plainwell Dam, looking southeast.

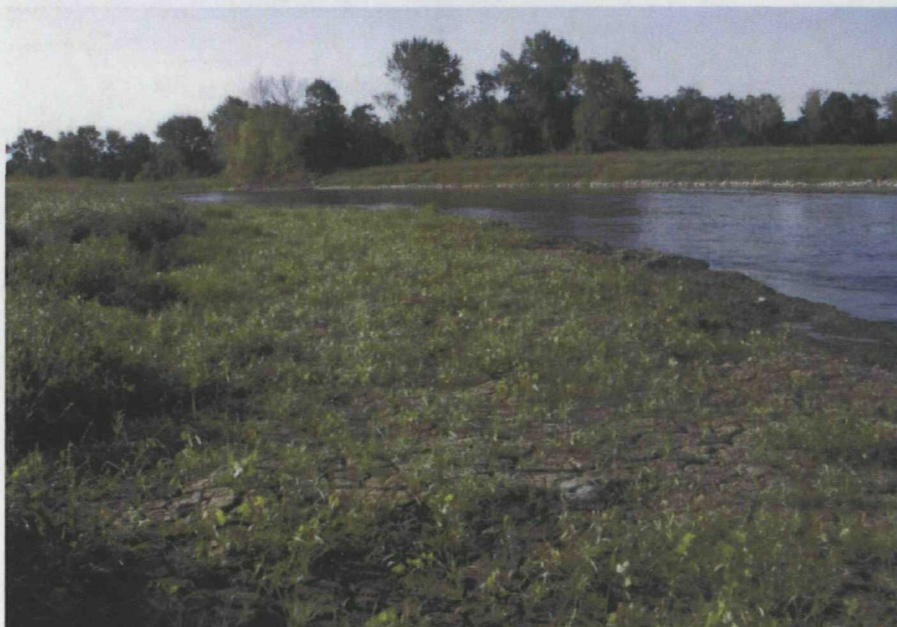
3

Photo #3: BEHI Area D (Very Low Erosion Potential) on north bank upstream of the former Plainwell Dam, looking southeast.

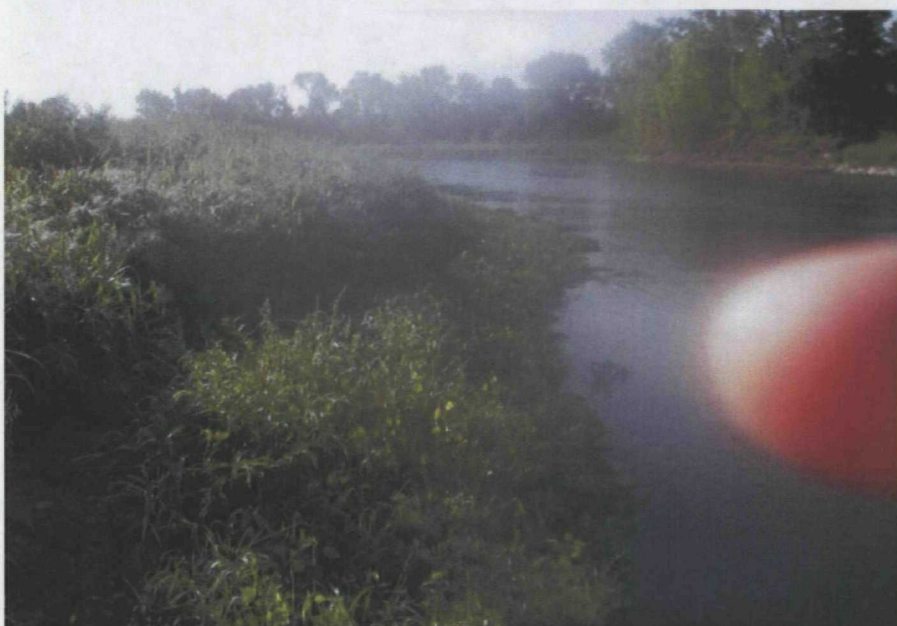
4

Photo #4: BEHI Area D (Very Low Erosion Potential) on north bank upstream of the former Plainwell Dam, looking east.

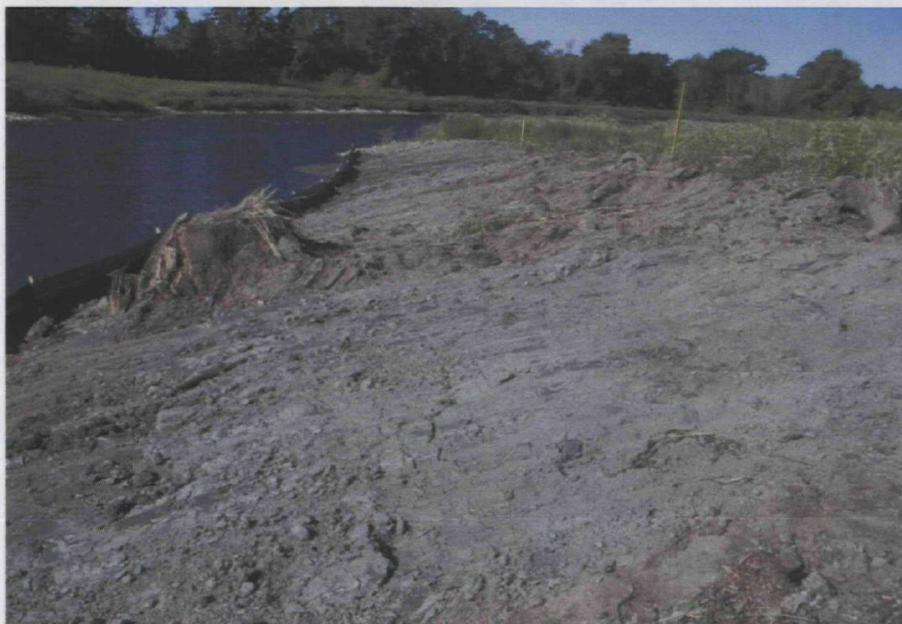
5

Photo #5: BEHI Area E (High Erosion Potential) on north bank at the regraded gas pipeline, looking southwest.

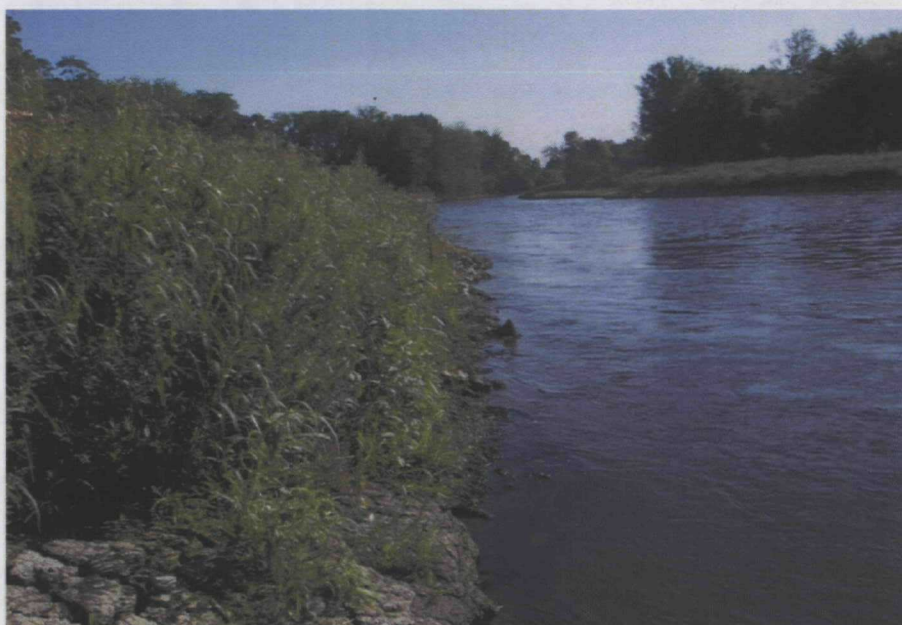
6

Photo #6: BEHI Area G (Moderate Erosion Potential) on north bank upstream of the gas pipeline, looking east.

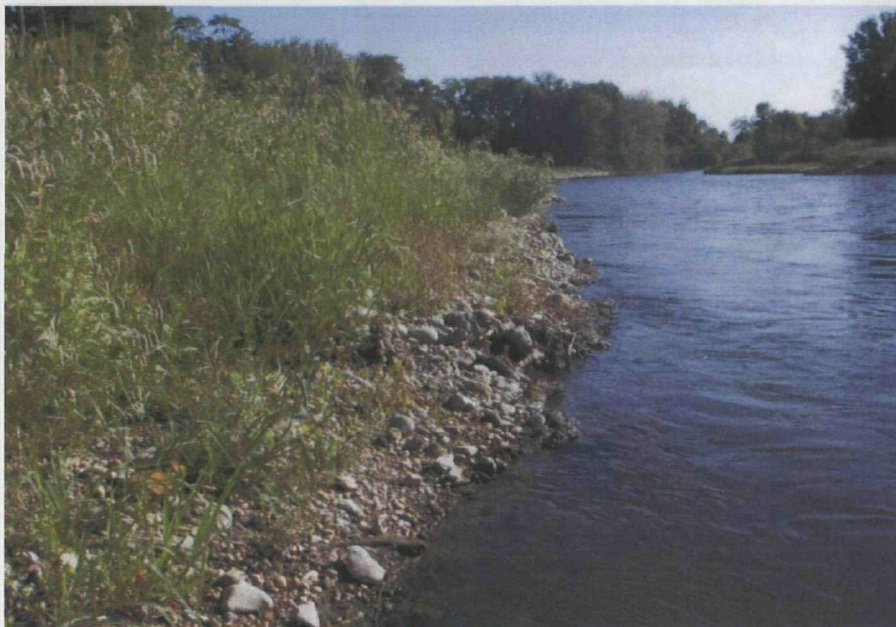
7

Photo #7: BEHI Area I (Very Low Erosion Potential) on north bank upstream of the US-131 bridge, looking east.

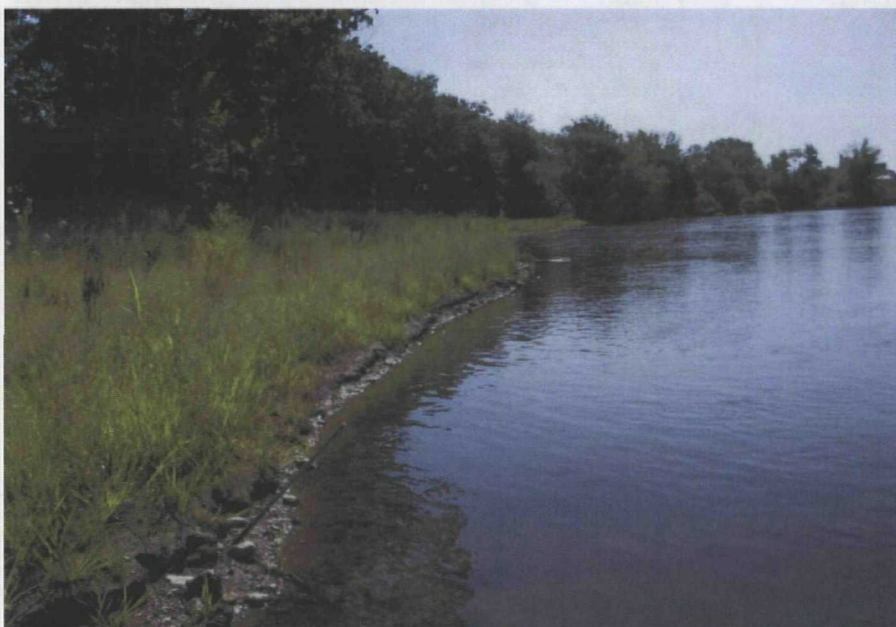
8

Photo #8: BEHI Area H (Very Low Erosion Potential) on north bank upstream of the US-131 bridge, looking east.

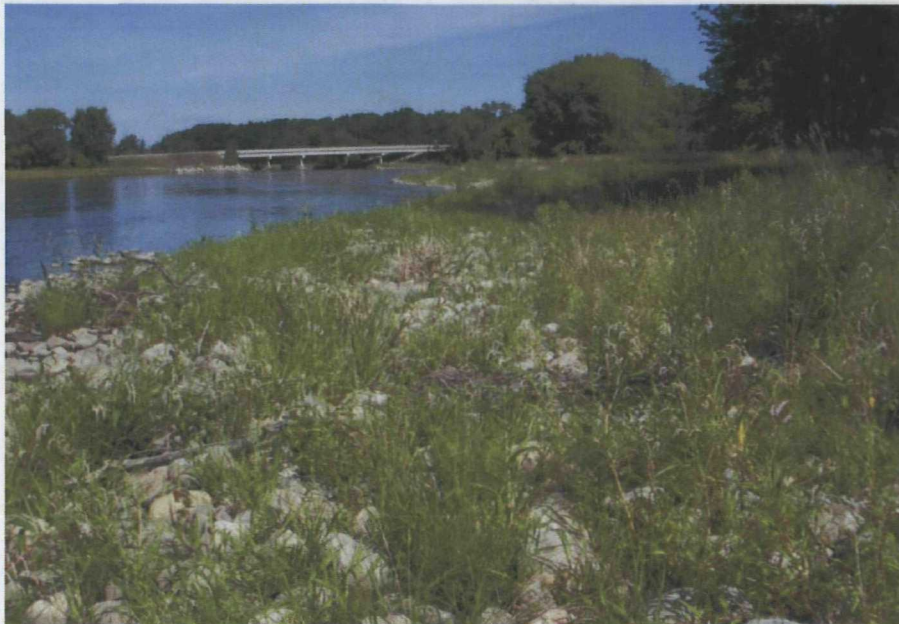
9

Photo #9: BEHI Area I (Very Low Erosion Potential) on north bank upstream of the US-131 bridge, looking west.

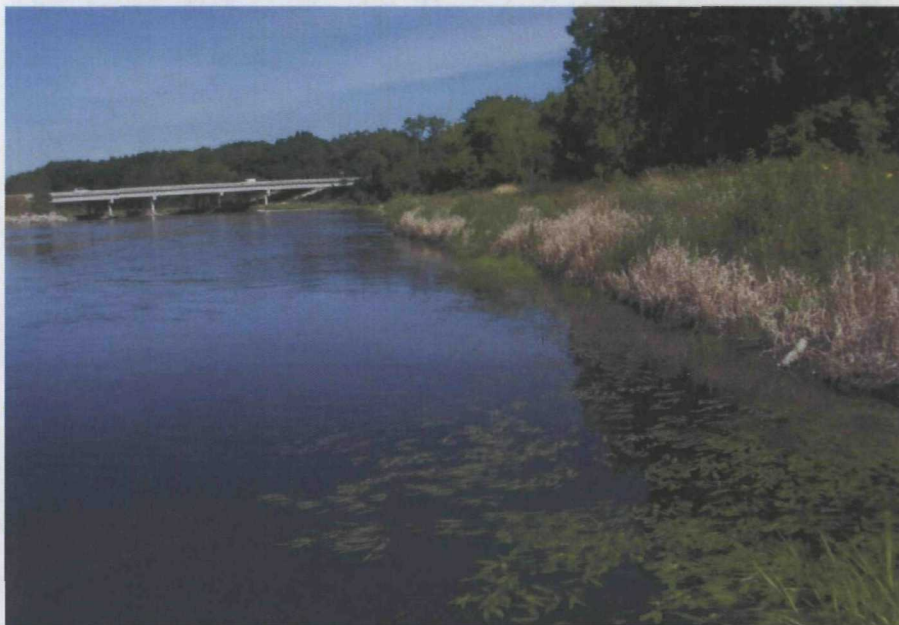
10

Photo #10: BEHI Area I (Very Low Erosion Potential) on north bank upstream of the US-131 bridge, looking west.

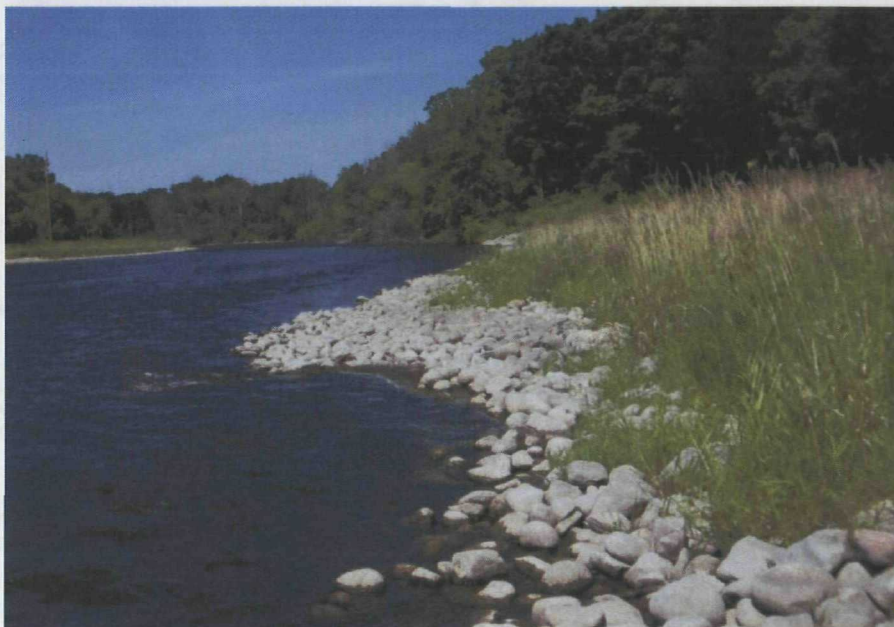
11

Photo #11: BEHI Area O (Low Erosion Potential) on south bank upstream of the US-131 bridge, looking east

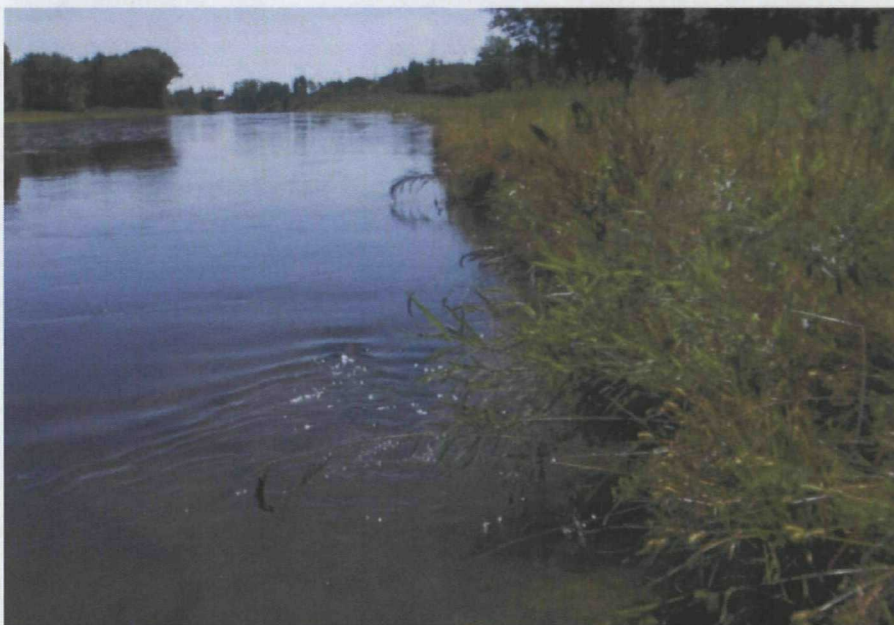
12

Photo #12: BEHI Area J (Moderate Erosion Potential) on south bank upstream of the US-131 bridge, looking east

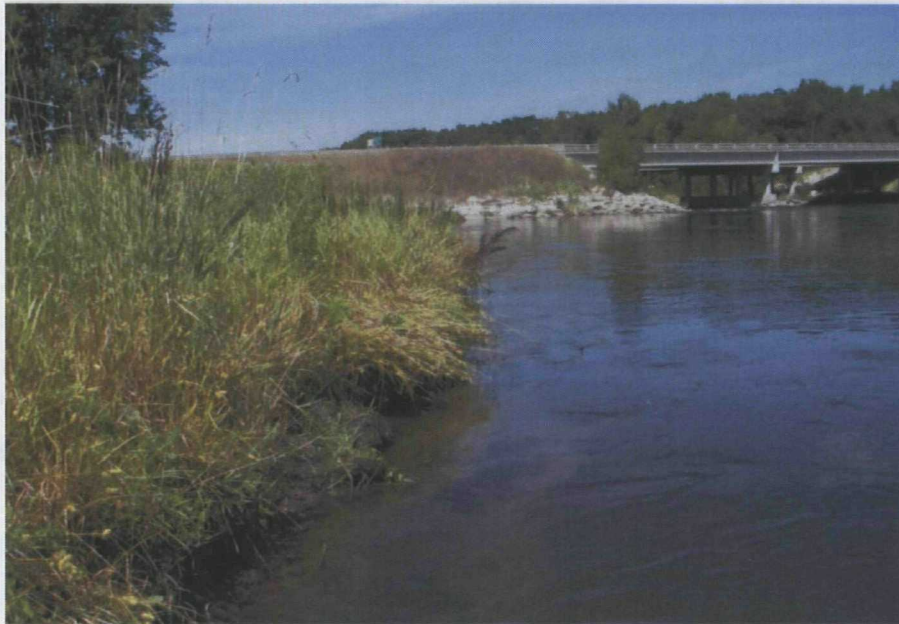
13

Photo #13: BEHI Area O (Low Erosion Potential) on south bank upstream of the US-131 bridge, looking west.

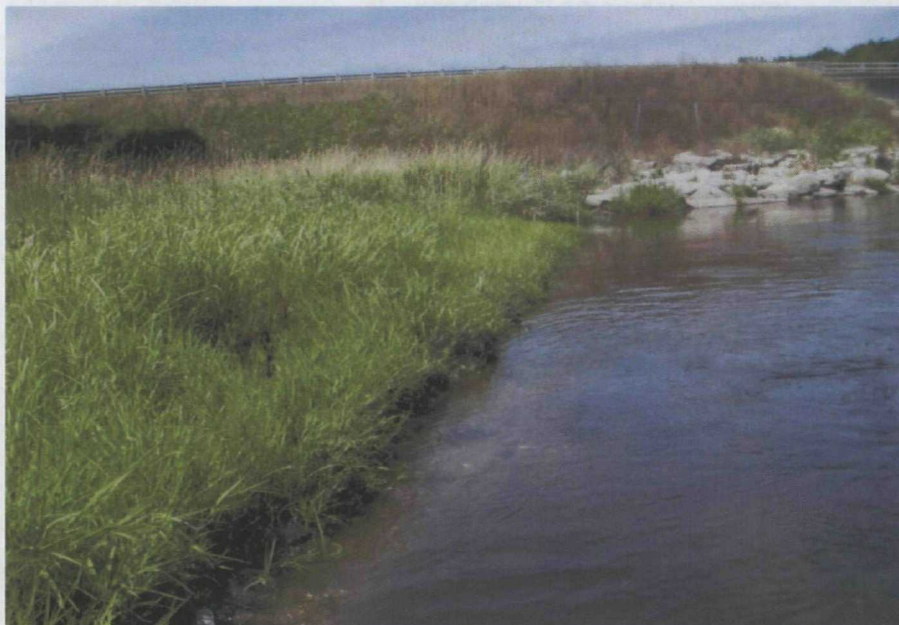
14

Photo #14: BEHI Area J (Moderate Erosion Potential) on south bank upstream of the US-131 bridge, looking west.

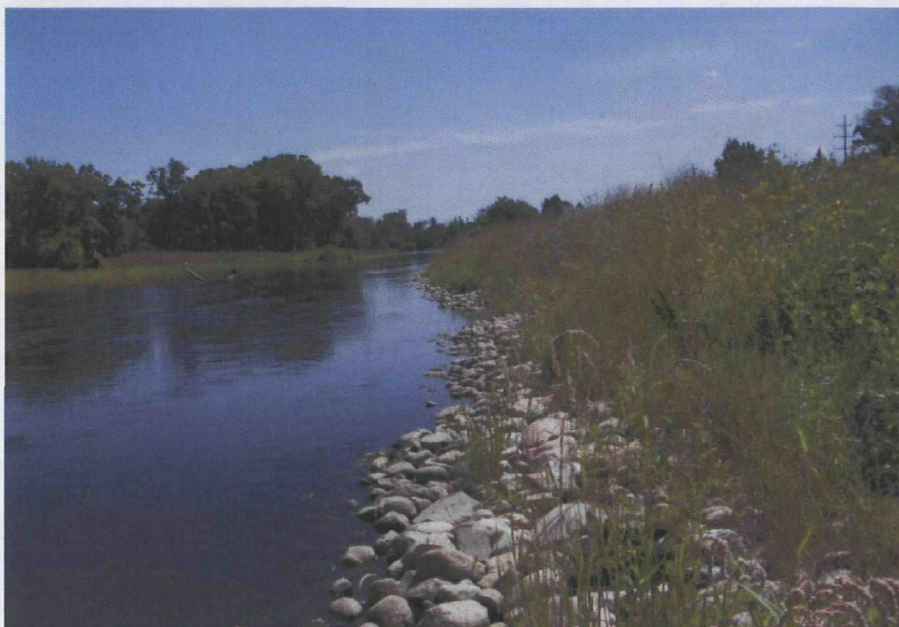
15

Photo #15: BEHI Area O (Low Erosion Potential) on south bank upstream of the US-131 bridge, looking east.

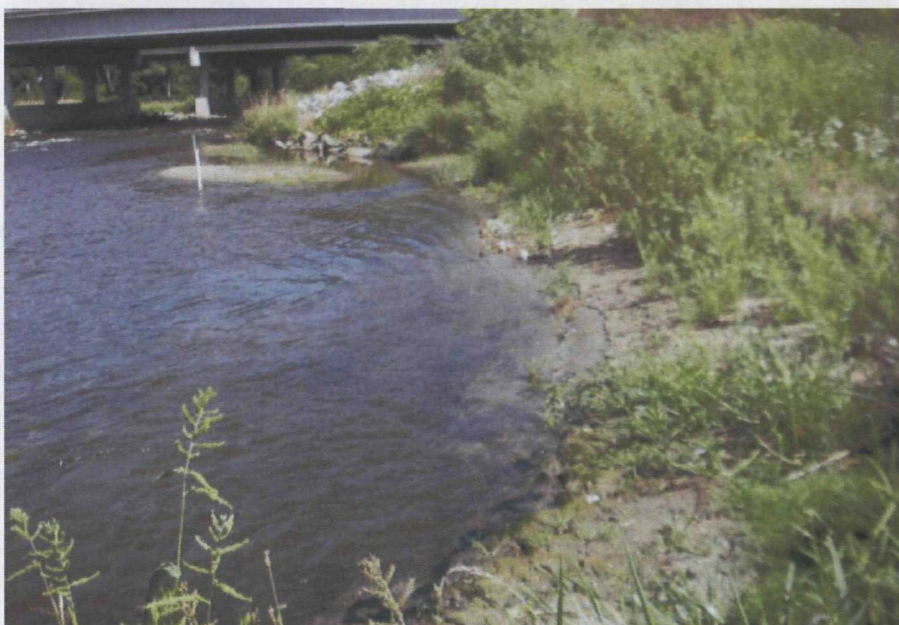
16

Photo #16: BEHI Area A (Moderate Erosion Potential) on south bank downstream of the US-131 bridge, looking east.

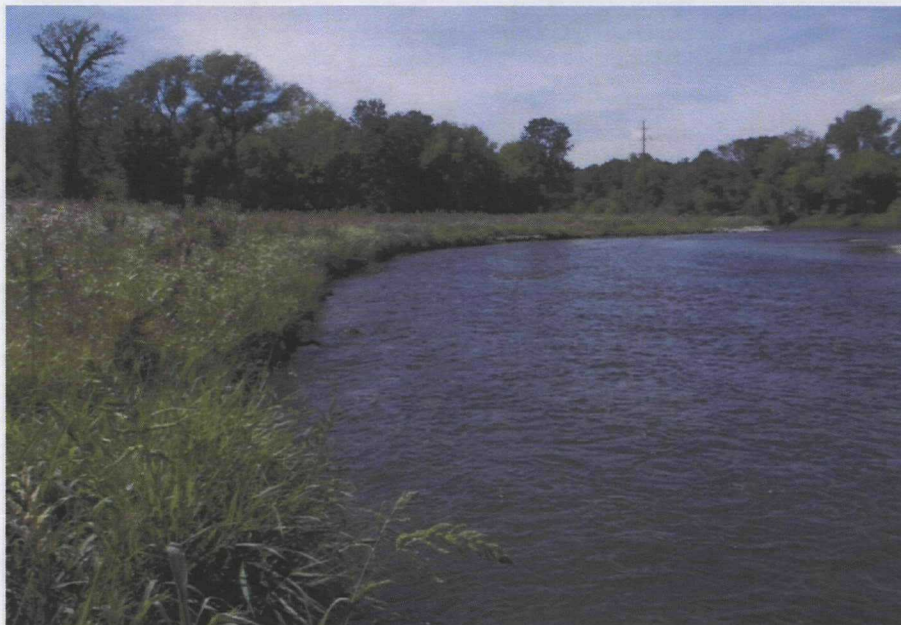
17

Photo #17: BEHI Area N (High Erosion Potential) on south bank downstream of the US-131 bridge, looking west.

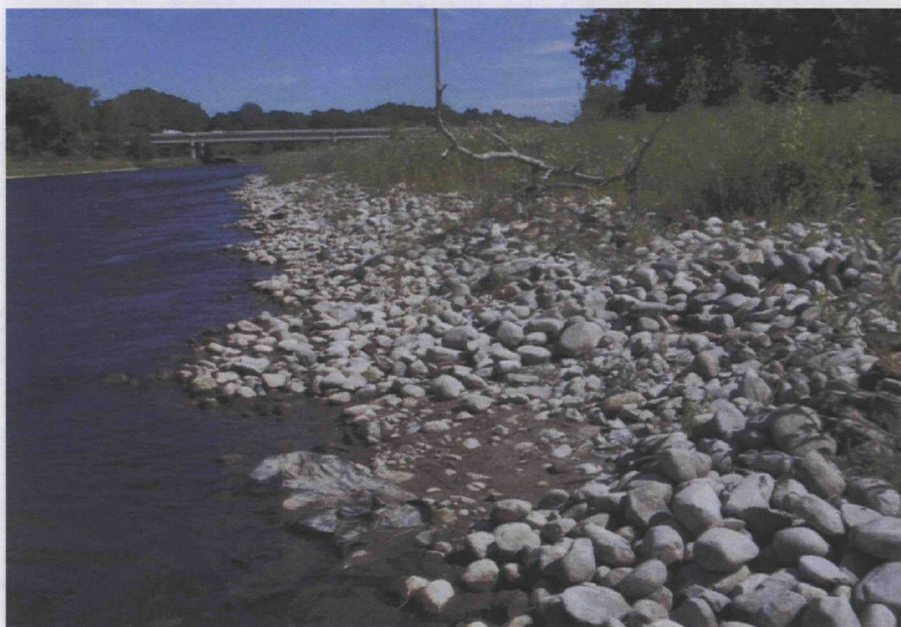
18

Photo #18: BEHI Area O (Low Erosion Potential) on south bank downstream of the US-131 bridge, looking east.

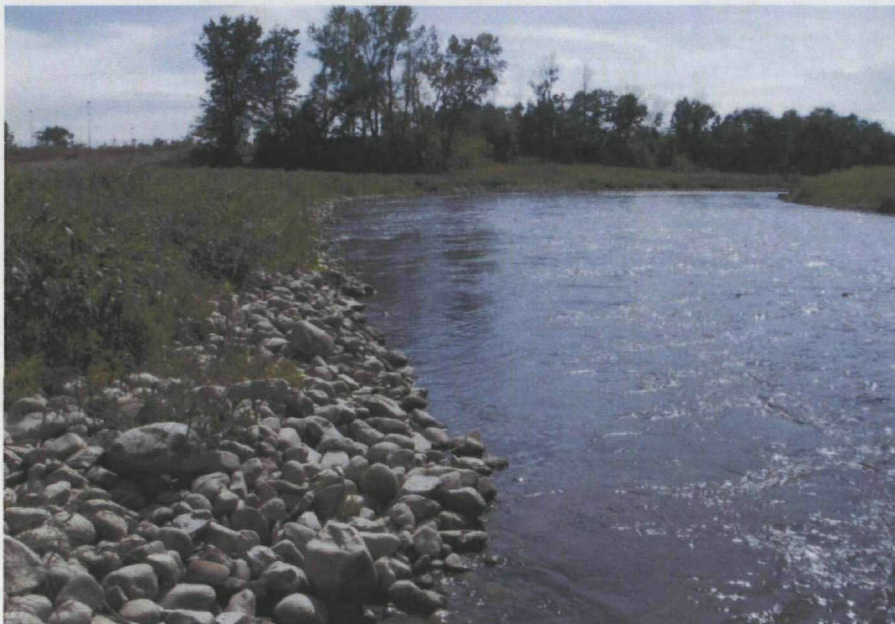
19

Photo #19: BEHI Area J (Moderate Erosion Potential) on south bank downstream of the US-131 bridge, looking west.

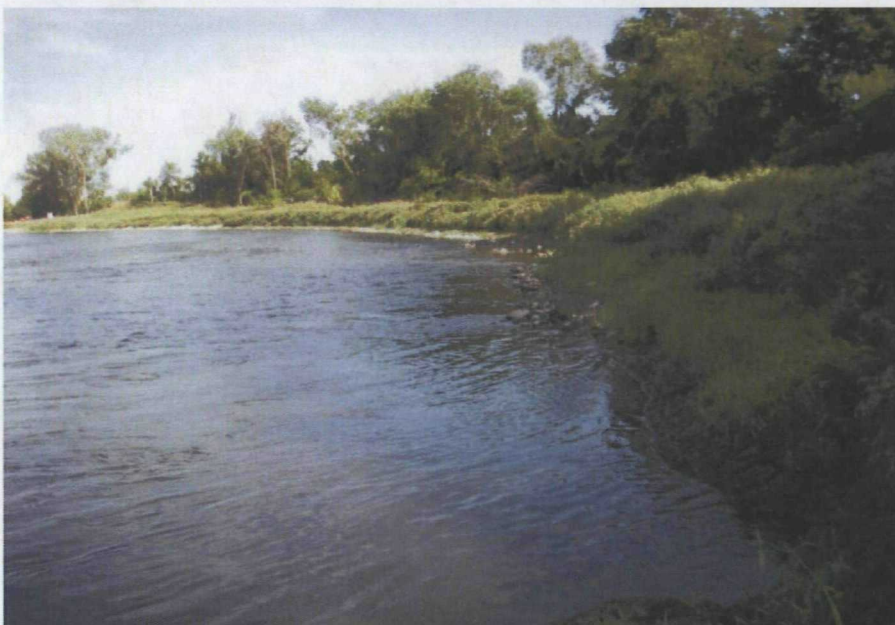
20

Photo #20: BEHI Area O (Low Erosion Potential) on south bank upstream of the former Plainwell Dam, looking east.

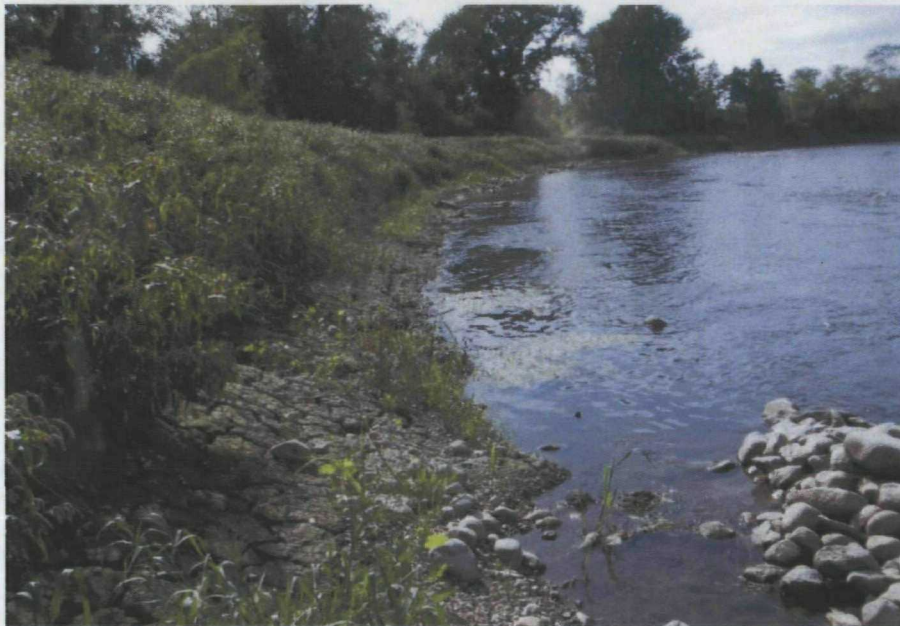
21

Photo #21: BEHI Area O (Low Erosion Potential) on south bank upstream of the former Plainwell Dam, looking west.

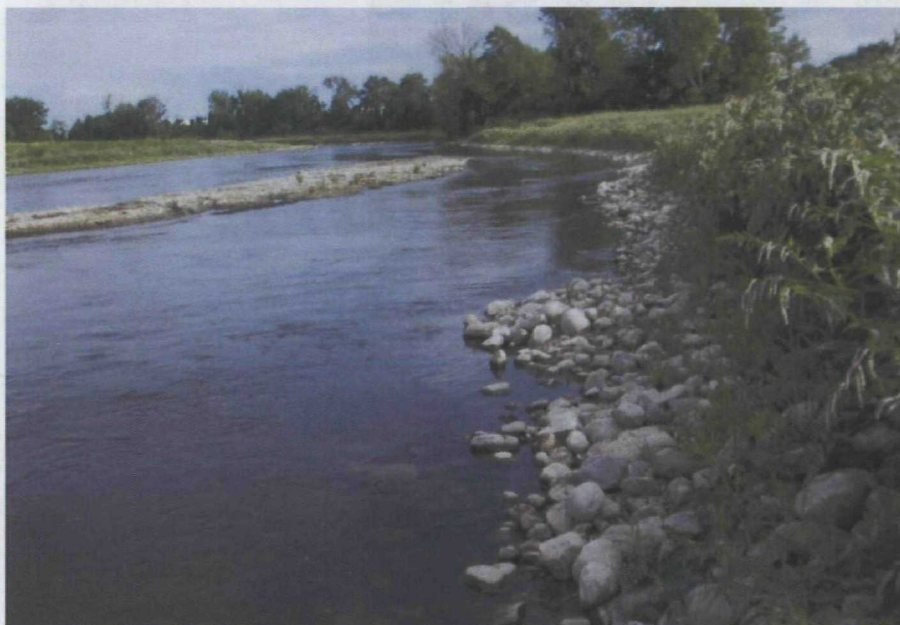
22

Photo #22: BEHI Area K (Low Erosion Potential) on south bank upstream of the former Plainwell Dam, looking east.

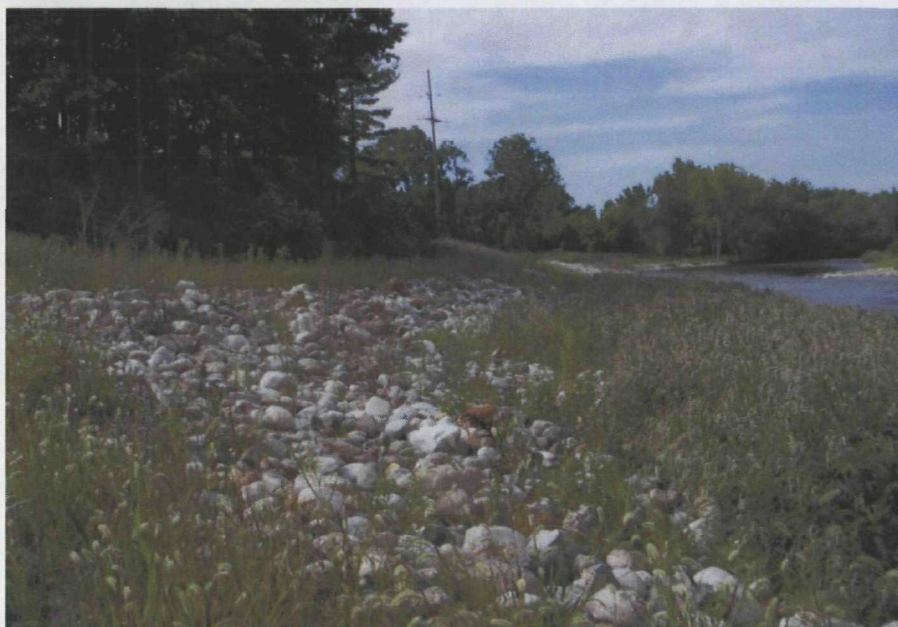
23

Photo #23: BEHI Area K (Low Erosion Potential) on south bank upstream of the former Plainwell Dam, looking west.

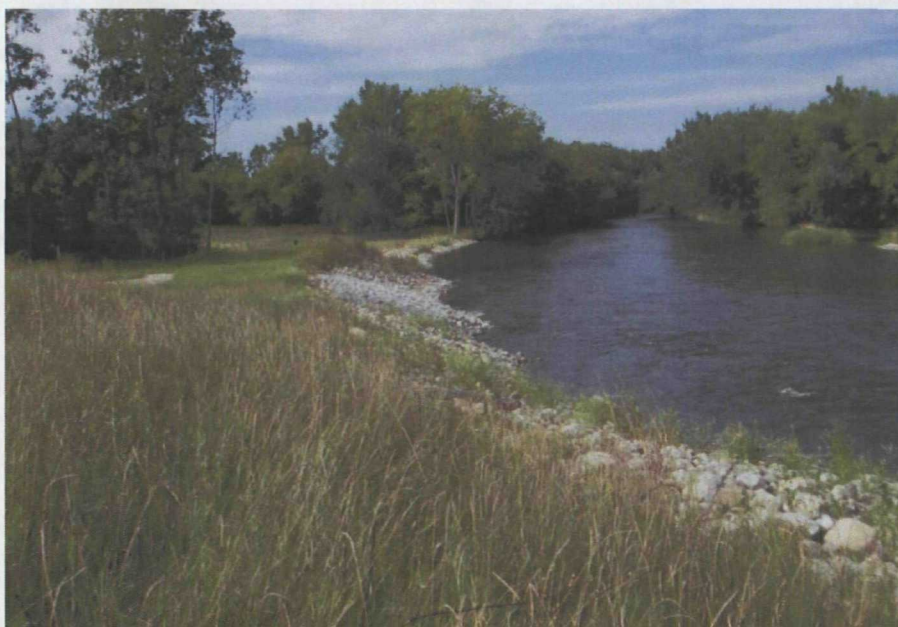
24

Photo #24: BEHI Area H (Very Low Erosion Potential) on south bank downstream of the former Plainwell Dam, looking west.

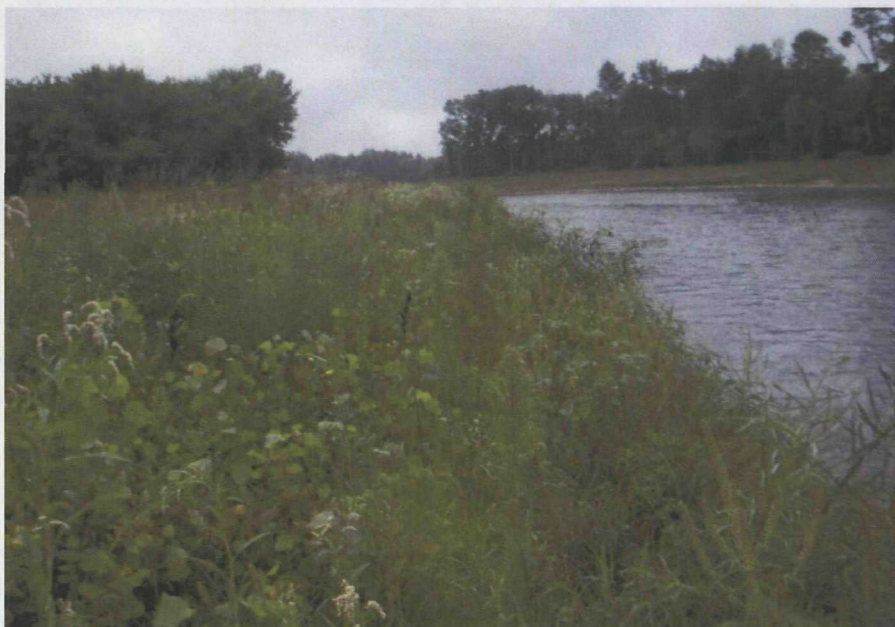
35

In 2009, during a bank inspection with USEPA and the Trustees, a section of bank in Removal Areas 8 and 9B was observed to have eroded. The original design for the restoration of this area included a flat shelf that extended 30 feet into the river at the anticipated prism-out median flow water elevation. This shelf was to be seeded if exposed, or planted with plugs if frequently inundated. After completion of the restoration of the bank in fall 2008, water levels were too high for seeding or installation of erosion control fabric; therefore, the protection and vegetation of the shelf was deferred until the following spring. During the severe storm flows that occurred in September 2008 and the winter and spring of 2009, the majority of the shelf eroded away before protective vegetation and erosion control fabric could be installed. As a result, much of the 30-foot buffer between the river and the bank eroded. The proposed design for the repair of the bank utilizing rock armament has been submitted to USEPA and the Trustees and will be implemented in 2009 following approval. A permanent transect will be established in the repair area after the bank is repaired so the bank can be monitored in future monitoring events for changes. No other bank areas were identified as requiring maintenance or repair activities.

Photo #35: Vegetation of Removal Area 8, looking west from east end.

Based on the results of the spring and summer 2009 monitoring events, the need for maintenance activity was identified for the south bank in the vicinity of Removal Areas 8 and 9B. A response action has been proposed for implementation in fall 2009 with the concurrence of USEPA and the Trustees (ARCADIS 2009). The 2010 monitoring report will include a description of the repair. No other maintenance activities were identified during the 2009 monitoring activities. Observed conditions will continue to be monitored in future annual events and the need for maintenance or repair actions will be assessed and implemented, as needed.

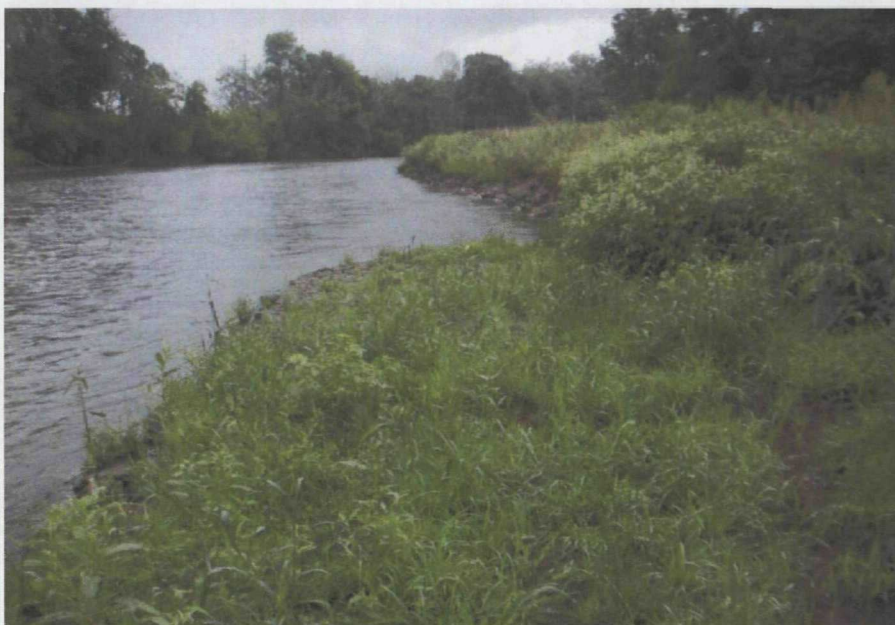
36

Photo #36: Vegetation of eastern portion of Removal Area 9B, looking east from east end.
